HARMONIC® HD 1000i

Optimized Device Performance Guide

Cleaning Instructions and Troubleshooting

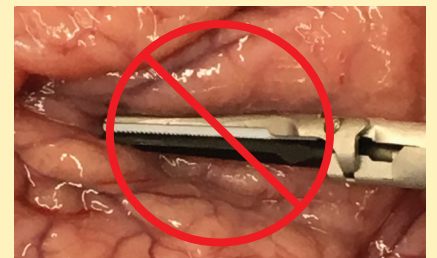
Caution

- Tissue pad damage may occur if device is activated without tissue in the closed jaws. Activation without tissue between the jaws will cause tissue pad degradation.
- Avoid contact with any and all metal or plastic instruments or objects such as graspers, uterine manipulators, etc.

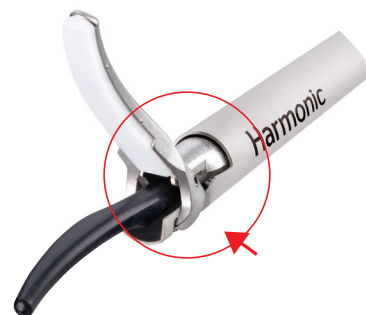
Cleaning with moist gauze

1. The jaws should be cleaned with a moist gauze sponge throughout the procedure.
2. If tissue is still visible in the clamp arm, use hemostats to remove residue.

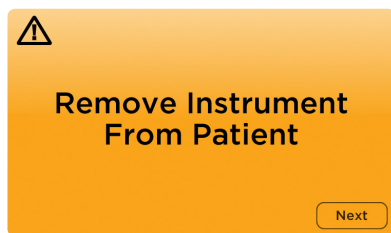
When the GEN 11 identifies high load (impedance), the “Remove Instrument from Patient” alert screen will be displayed.

The “Remove Instrument from Patient” alert screen is informing the user of an increased load (impedance) on the device.

There are many factors that can lead to an increased load (impedance) on the system, including excessive debris within the jaws, or contact with metal or plastic instruments when the instrument is activated. It is necessary for the GEN11 to monitor device impedance in order to confirm proper device function and blade integrity throughout the surgical procedure.

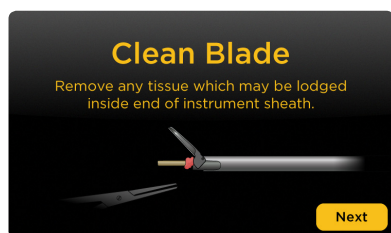
After the Operating Room staff presses Next, the GEN 11 will prompt the user to “Clean Blade; Remove any tissue which may be lodged inside end of instrument sheath.”

At this point the sterile surgical staff should thoroughly clean the device by wiping the blade, tissue pad, and distal shaft with a moist gauze sponge to remove tissue. If tissue is still visible in the clamp arm, use hemostats to remove residue, taking care not to activate the instrument while cleaning.
